## Initial Leakage in the Mechanical seal of Water Pump

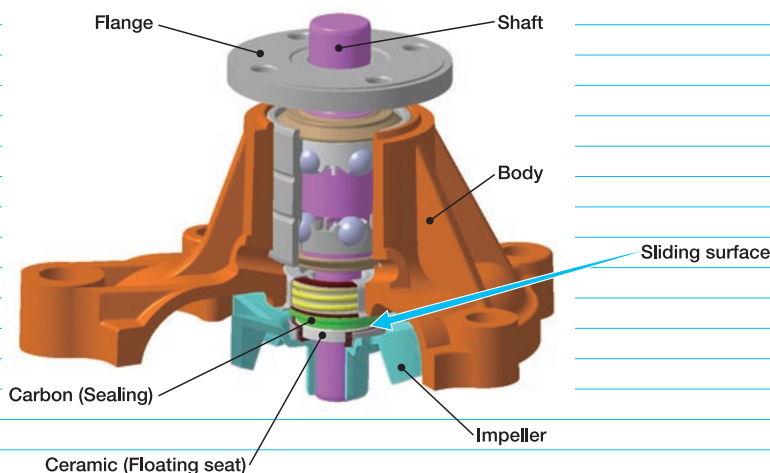
### The structure of a water pump

First, please see the drawing 'Structure of water pump' below that will make it clearer to you. We can divide the mechanical seal of a water pump into a rotating part and a non-rotating part. We describe the contact point of these two parts as a sliding surface.

The rotating part is made of ceramics, and the non-rotating part is made of carbon. The ceramic part rotates so fast against the carbon part that frictional heat is generated. We choose ceramics and carbon as they can withstand high temperatures. We design the sliding surface so as to utilize the coolant as a lubricant to prevent heat damage. A small amount of coolant will evaporate at the sliding surface.

The vaporized steam will exhaust through the drain hole, but we cannot see it. Due to the temperature change outside the vapor will condense to liquid leaving a tiny residue. This evaporation and condensation of the coolant is the reason there is a drain hole in water pumps.

This is due to the sliding surfaces generating a lot of friction before they settle together and benefit from the lubricating properties of the coolant mix which then creates a stable and consistent seal.

So, we can say this small 'leak' is just a part of the bedding-in process for the seal. We hope this explanation will be useful for all our customers to remove these claims and save costs for us all.
